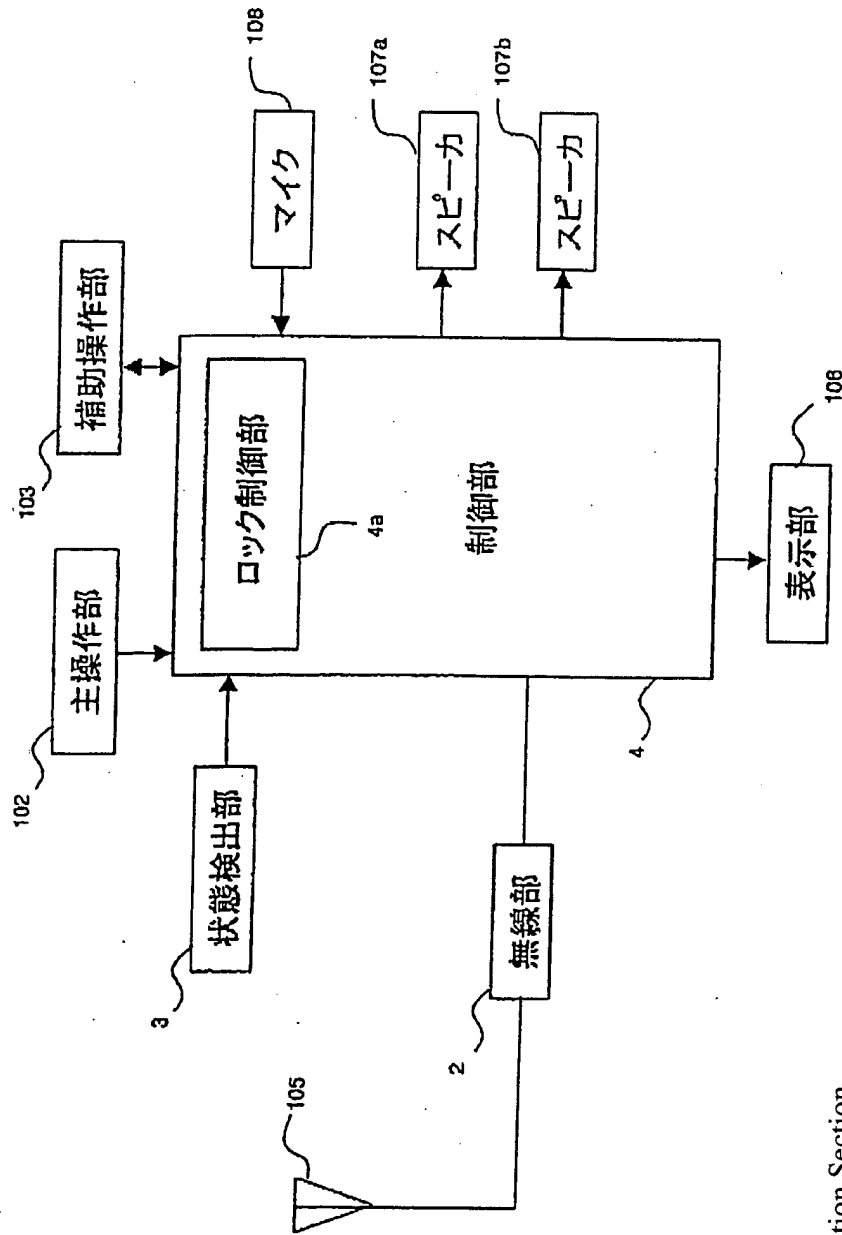
Fig. 4

- 2 Wireless Section
- 3 State Detecting Section
- 4 Control Section
- 4a lock Control Section
- 102 Main Operational Operation Section
- 103 Auxiliary Operational Operation Section
- 106 Display Section
- 107a, 107b Speaker
- 108 Microphone

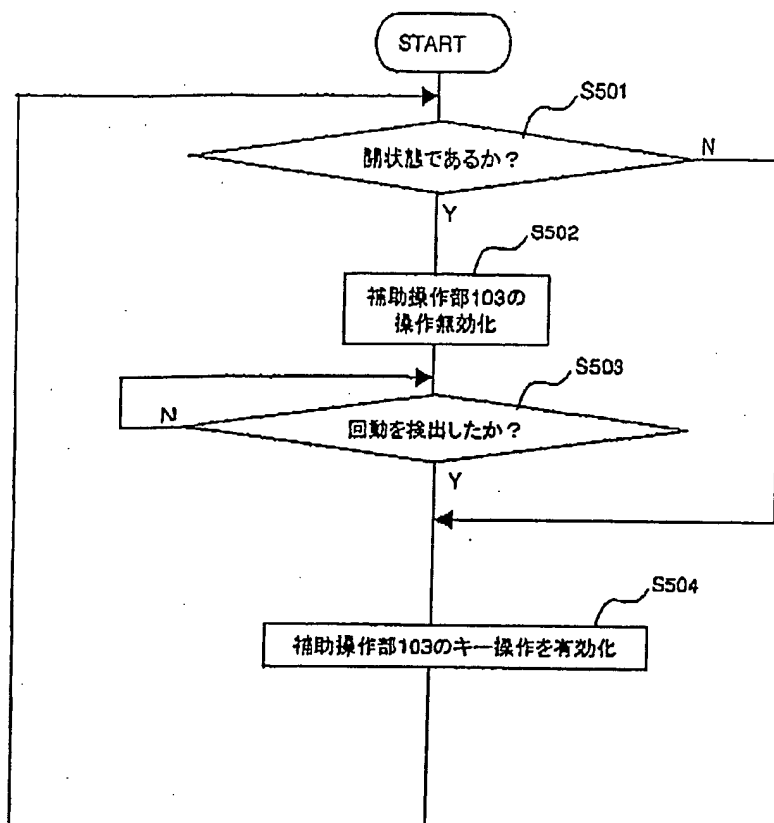
Fig. 5

| S501 | Housings are in Open State? |
| S502 | Invalidation of Operation of

Auxiliary Operational Operation Section 103 |

| S503 | Rotation is Detected? |
| S504 | Validation of Operation of

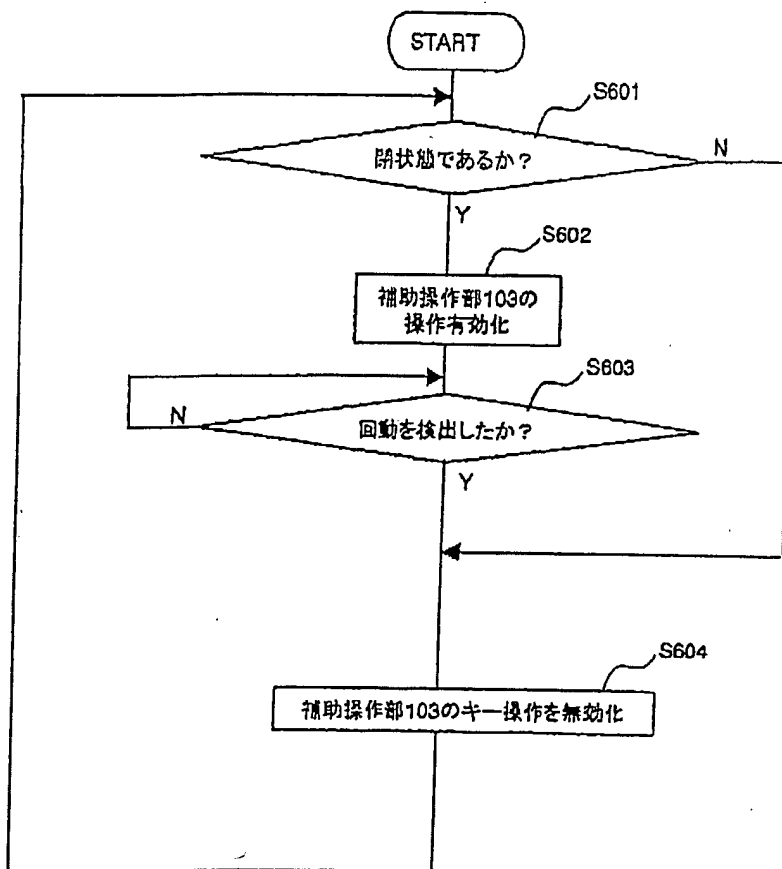
Fig. 6

| S601 | Housings are in Close State? |
| S602 | Validation of Operation of

Auxiliary Operational Operation Section 103 |

| S603 | Rotation is Detected? |
| S604 | Invalidation of Operation of
